STREAMVIEW DRIVE TRAFFIC ANALYSIS REPORT

Prepared for:
Project Implementation and Technical Services (PITS)
City of San Diego
Engineering and Capital Projects Department
Transportation Systems and Programming

Prepared by:
City of San Diego
Engineering and Capital Projects Department
Transportation Systems Safety Programs
January 28, 2008

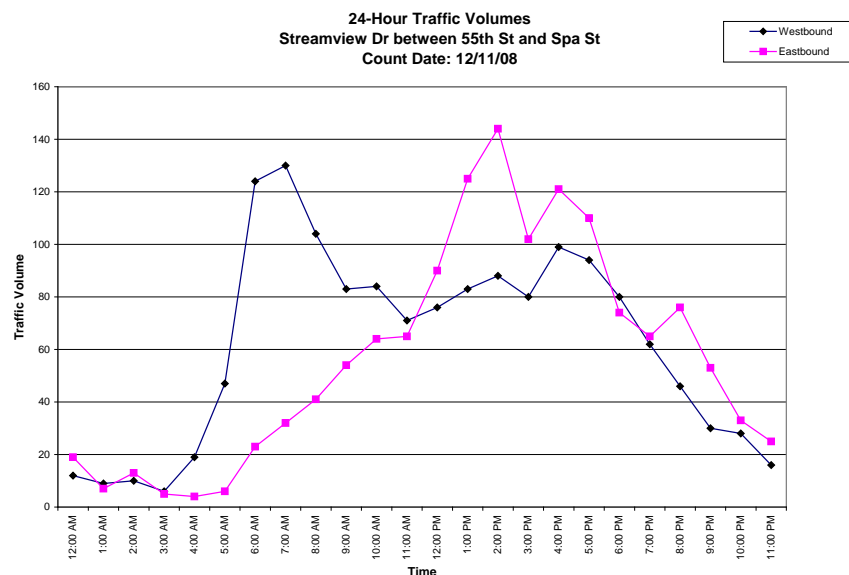
Figure 2: Hourly Traffic Volume for Streamview Dr (between 55th Street and Spa Street)

Twenty-four hour traffic volume surveys were conducted along Streamview Drive between 55th Street and Spa Street on December 11, 2008. The current daily traffic volume in this segment of Streamview Drive is approximately 2,800 vehicles. Figure 2 shows the 24-hour traffic volume profile for this section of roadway. This figure shows that traffic volumes peak between 7:00 AM and 8:00 AM in the westbound direction, and between 2:00 PM and 3:00 PM in the eastbound direction. Complete twenty-four hour traffic volume surveys can be found in the Technical Appendix.

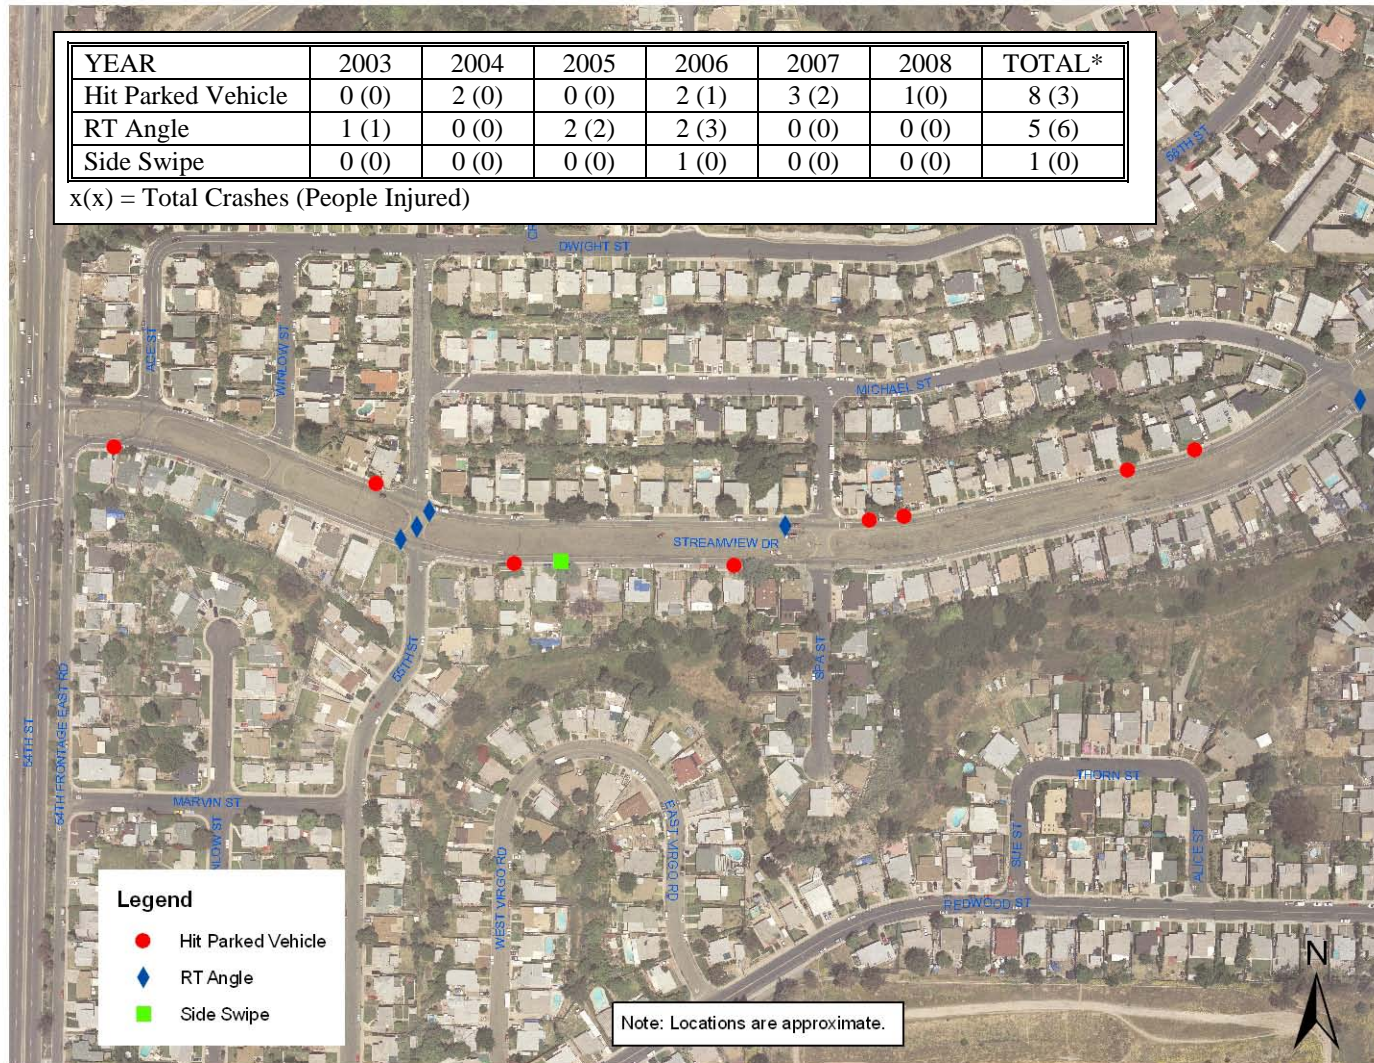
Figure 4: Historical Collision Data Over Time, Section 1 (2003-2008)

Crash rates are an effective tool to measure safety hazards at a particular section of roadway. Yearly crash rates from 2003 to 2008 were developed for this section of roadway. The crash rates at this segment of roadway are higher than the city-wide crash rates for minor collectors, especially for years 2006 and 2007.

This high crash rates are likely due to speeding, traffic control problems at intersections, and vehicles parking in the wide median. Measures need to be taken to mitigate and reduce the number of accidents in this section of roadway. Table 3 shows a summary of accidents and yearly crash rates for this section of Streamview Drive.

- Due to the high speeds along this section of roadway, a gateway is recommended at 54th Street to alert the drivers that they have entered a residential neighborhood.

- Based on the high number of right-turn accidents at the intersection of 55th Street/Streamview Drive, a traffic circle is recommended at this location. This traffic circle will also reduce speeds along the corridor.

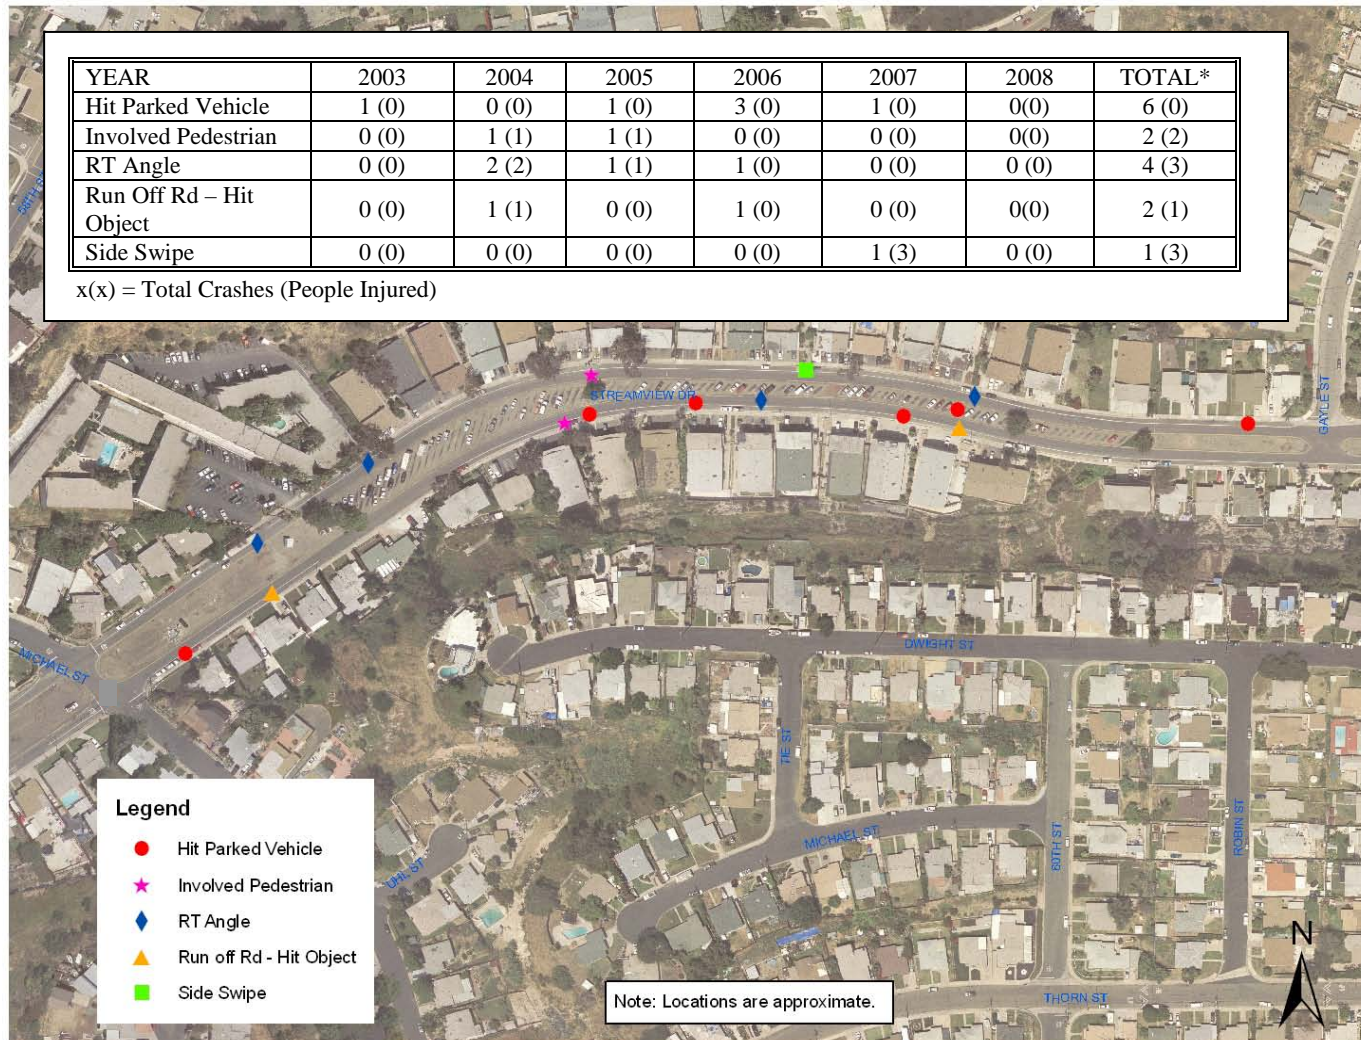
Figure 7: Historical Collision Data Over Time, Section 2 (2003-2008)

Historical collision data was analyzed for Streamview Drive between Lynn Street/Michael Street and Gayle Street. Collision Data was collected from the City of San Diego database for years 2003 through 2008. Figure 7 summarizes the historical collision data. During this period there were 15 collisions reported along this section of Streamview Drive. Of this 15 collisions, some of these accidents involved children pedestrians or bikes.

Crash rates are an effective tool to measure safety hazards at a particular section of roadway. Yearly crash rates from 2003 to 2008 were developed for this section of roadway. The crash rates at this segment of roadway are higher than the city-wide crash rates for minor collectors, especially for years 2004 and 2006. This high crash rates are likely due to speeding, and vehicles parking in the wide median. Measures need to be taken to mitigate and reduce the number of accidents in this section of roadway, especially because a lot of accidents involved children and bikes. Table 6 shows a summary of accidents and yearly crash rates for this section of Streamview Drive.

- A traffic circle is recommended at the Gayle Street/Streamview Drive intersection. This traffic circle will slow down traffic along the corridor.
- Remove obstructions to meet the 36" minimum clearance along pedestrian paths.
- Install urban parkways on both sides of the street. Urban parkways should include 8' sidewalks with 2'-3' planter strips or 6' sidewalks with 2'-3' parkway strips. 8' sidewalks are preferred.
- Install 5' bike lanes and 8' parallel parking on both sides of the street.
- Install 12' travel lanes in each direction of traffic.
- Median to include 96 striped parking spaces. West and east of this parking area, median must taper to double yellow striping or 4' max. raised median.
- Evaluate existing street lighting and install new lights as needed.
- Install appropriate signing and striping along the corridor.

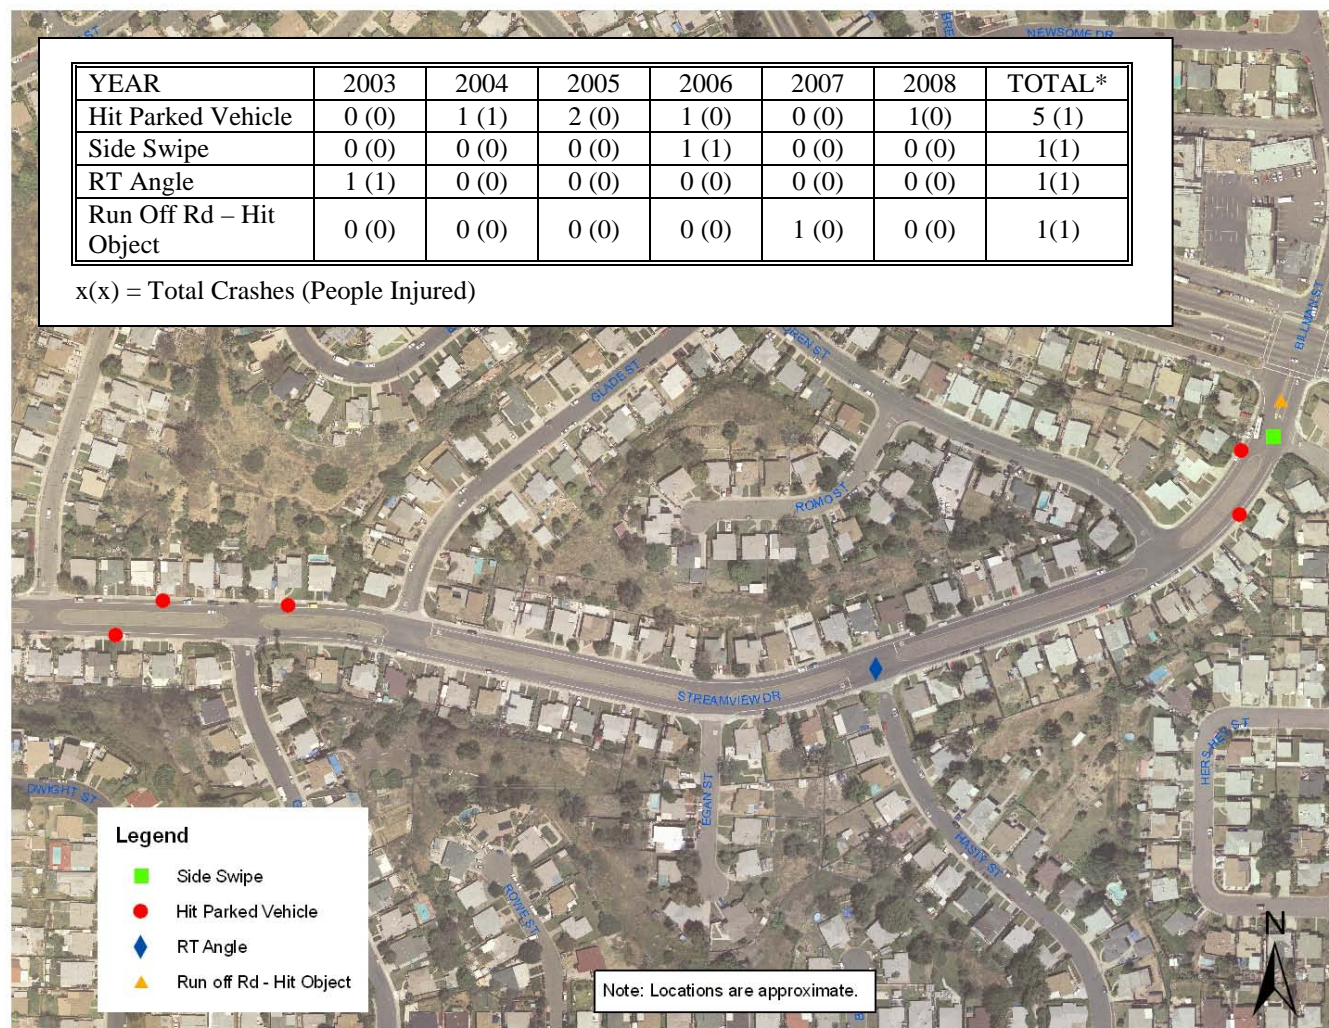
Figure 10: Historical Collision Data Over Time, Section 3 (2003-2008)

Historical collision data was analyzed for Streamview Drive between Gayle Street and College Avenue. Collision Data was collected from the City of San Diego database from years 2003 to 2008. During this period there were 8 collisions reported. Figure 10 summarizes the historical collision data.

Crash rates are an effective tool to measure safety hazards at a particular section of roadway. Yearly crash rates from 2003 to 2008 were developed for this section of roadway. The crash rates at this segment of roadway are higher than the city-wide crash rates for minor collectors. Measures need to be taken to mitigate and reduce the number of accidents in this section of roadway. Table 9 shows a summary of accidents and yearly crash rates for this section of Streamview Drive.

- Due to the high speeds along this section of roadway, a gateway at College Avenue is recommended to alert the drivers that they have entered a residential neighborhood.

- A traffic circle is recommended at the Boren Street/Streamview Drive intersection. This traffic circle will slow down traffic along the corridor.
- Remove obstructions to meet the 36" minimum clearance along pedestrian paths.
